Nuisance Mechanical Plant Investigation

42 Carlos Street, Aberfoyle 2055

Final Report – 1040-01

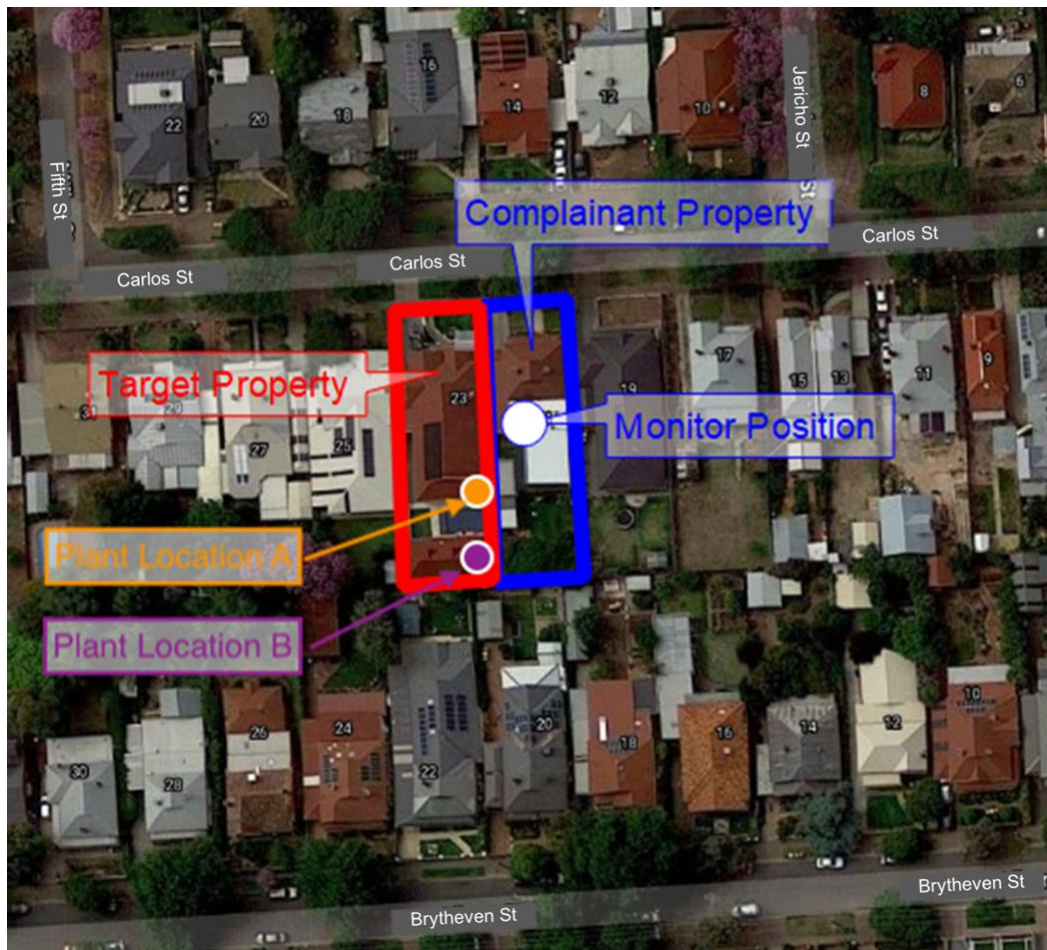
The complainant property, (42 Carlos Street, Aberfoyle 2055) is located in a primarily residential area. The acoustic environment is typical of a residential area, with noise from general residential activities impacting the property. Particularly, noise associated with the operation of fixed mechanical plant at 40 Carlos street, including a reverse cycle air conditioner, inbuilt house vacuum and pool pump and filtration equipment located next door at 40 Carlos Street, Aberfoyle 2055, has been noted as a source of noise nuisance for the complainant. See Figure 1 for details.

Figure 1 – Complainant property, surrounding residents and noise monitoring location.

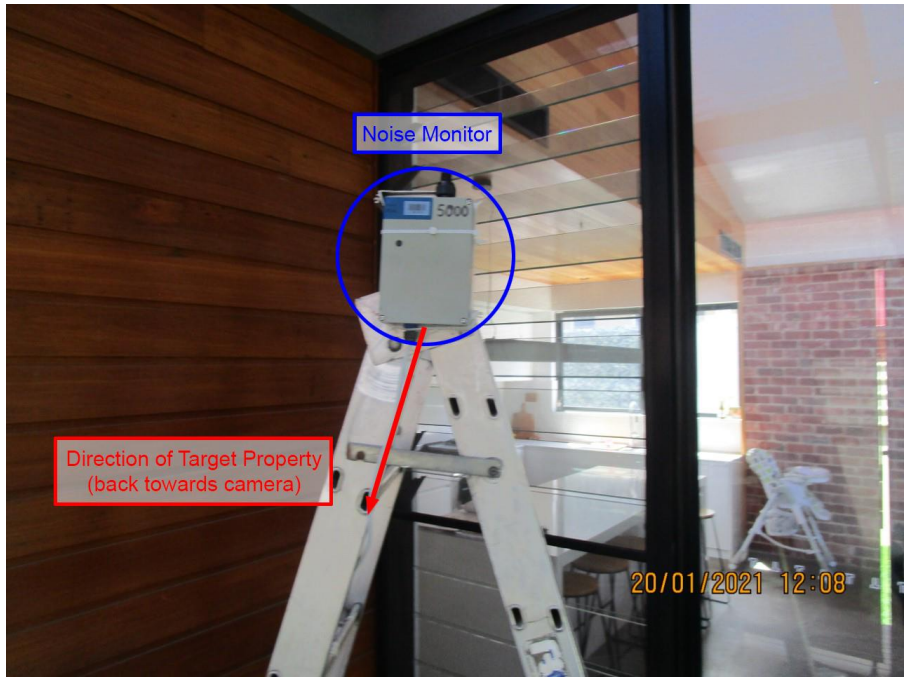
The noise monitor was installed on a ladder at the alfresco deck on the west part of 42 Carlos Street, approximately 2 meters above ground level and 10 meters from the mechanical plant at 40 Carlos Street. A masonry wall divides the two properties, and obscures line of sight between the noise monitor and mechanical plant. Refer to Figure 1, Figure 2 and Figure 4 for further details. The monitoring position was chosen to allow clear measurement of the mechanical plant as it impacts external habitable areas of the complainant property, as well as the façade of internal lounge and living areas.

Figure 2 - Noise monitor location, in situ.

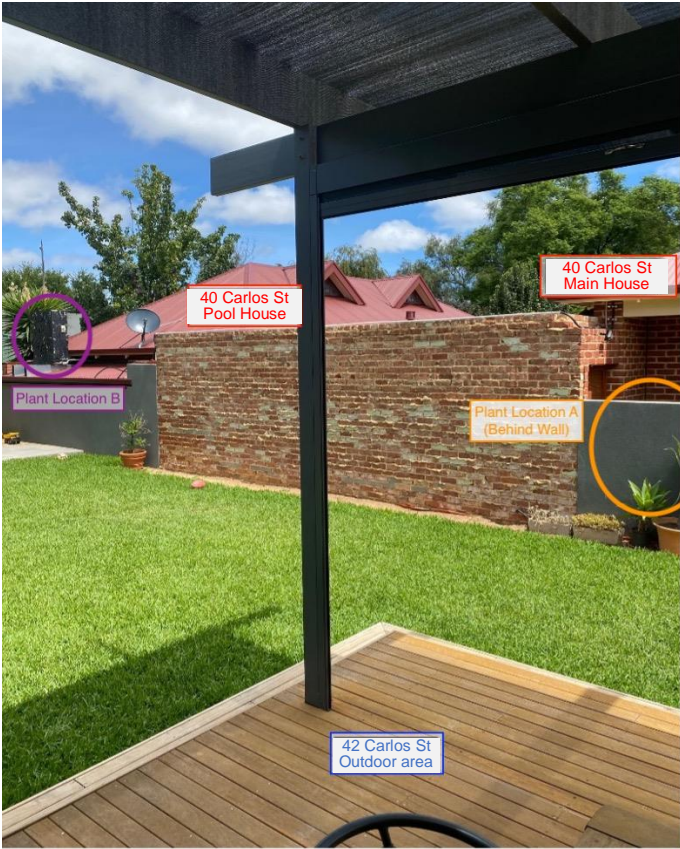
Figure 3 – View of Mechanical Plant locations, from complainant property.

The physical location, orientation and installation of mechanical plant at Locations A and B appear to have had little consideration given to the impact they may cause to residents at 42 Carlos Street. There is direct line of site to the AC unit at location B, and the hard reflective surfaces surrounding the plant at location A mean that the majority of noise from these plant are projected into noise sensitive areas of 42 Carlos Street.

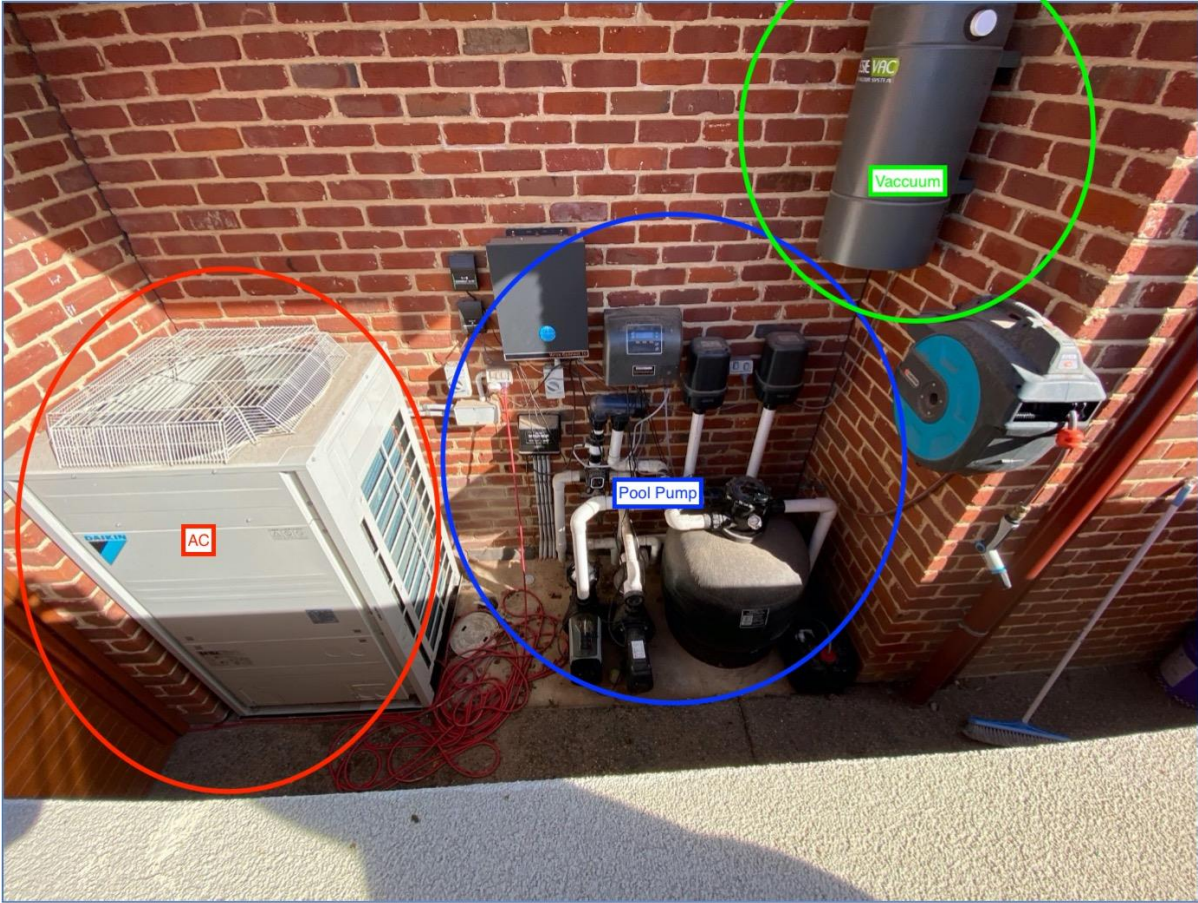
Figure 4 – View of Target Mechanical Plant at Location A, looking over the fence.

It is highly recommended that a suitably qualified acoustic consultant perform a thorough review of all mechanical plant located at 40 Carlos Street, and provide guidelines on any mitigation measures, and/or usage restrictions that may be required to ensure compliance with regulations and reasonable acoustic amenity is achieved. If possible, usage of the AC unit and Vacuum

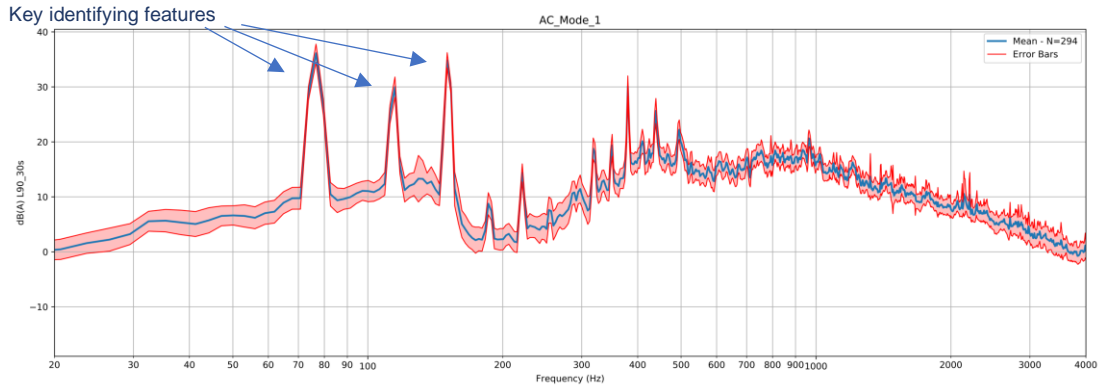
The AC unit was observed to have a number of operating modes. Most operating modes showed three strong tonal features at approximately 75Hz, 110Hz and 150Hz (Operating Mode 1, Figure 5), which decreases in frequency by approximately 15 Hz in Operating Mode 2 (Figure 6). The observed AC spectrum is appropriate to have a +8dB penalty applied to the continuous source noise level, for tonal and low frequency characteristics, when compared to EPP criteria.

Figure 5 – Spectral Content of the AC unit – Operating Mode 1

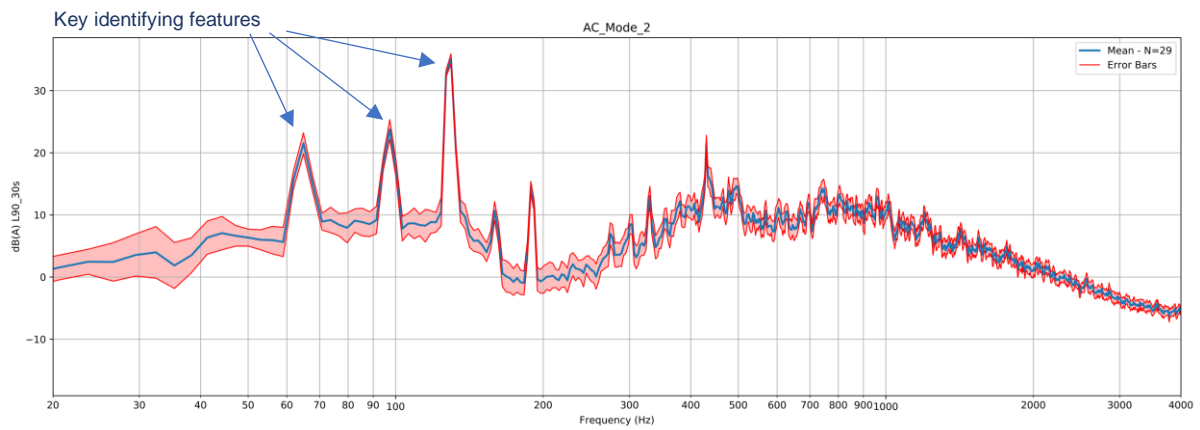
Figure 6 – Spectral Content of the AC unit – Operating Mode 2

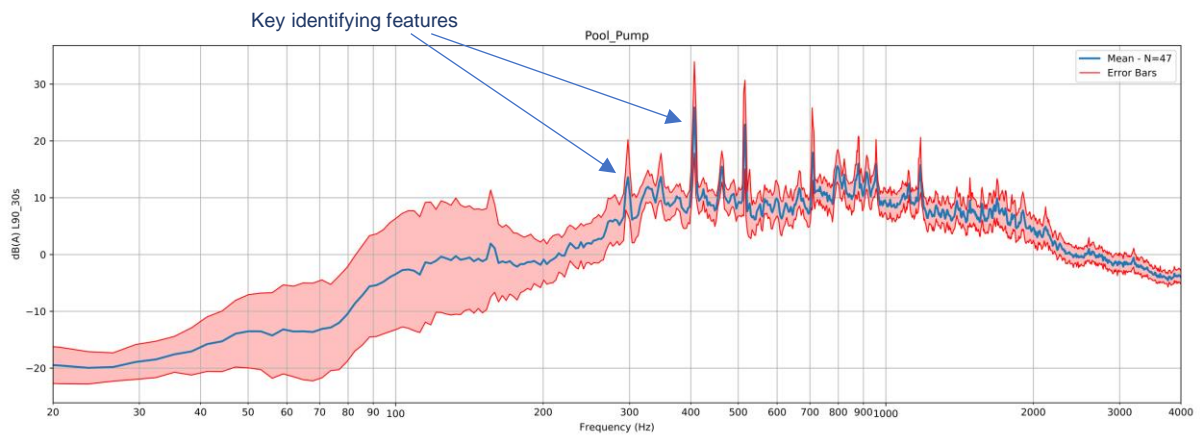
The Pool Pump was found to have primary tonal features at approximately 300Hz and 400Hz, shown in Figure 7. The observed Pool Pump spectrum is appropriate to have a +5dB penalty applied to the continuous source level, for a tonal characteristic, when compared to EPP criteria.

Figure 7 – Spectral Content of the Pool Pump

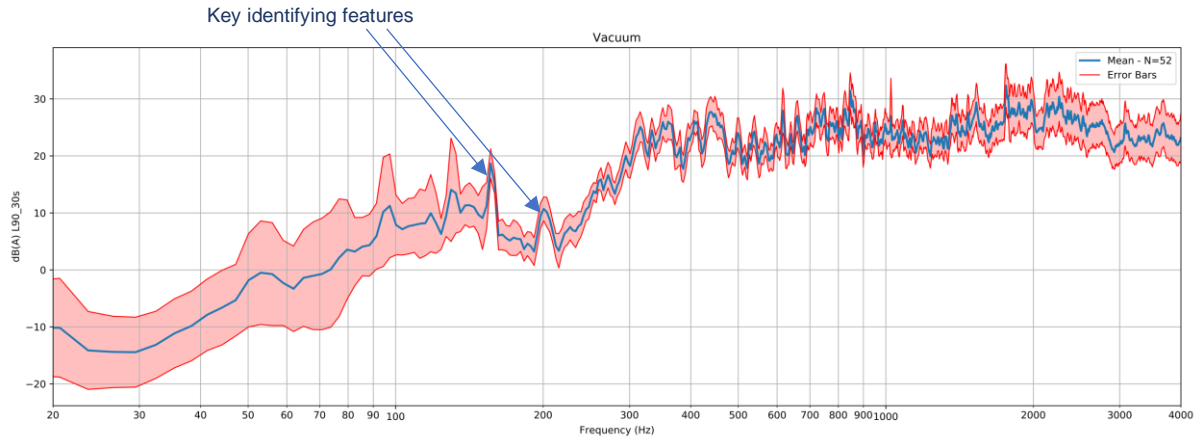
The Vacuum was observed with some tonal features at approximately 150Hz and 200Hz, shown in Figure 8.

Figure 8 – Spectral Content of the Vacuum

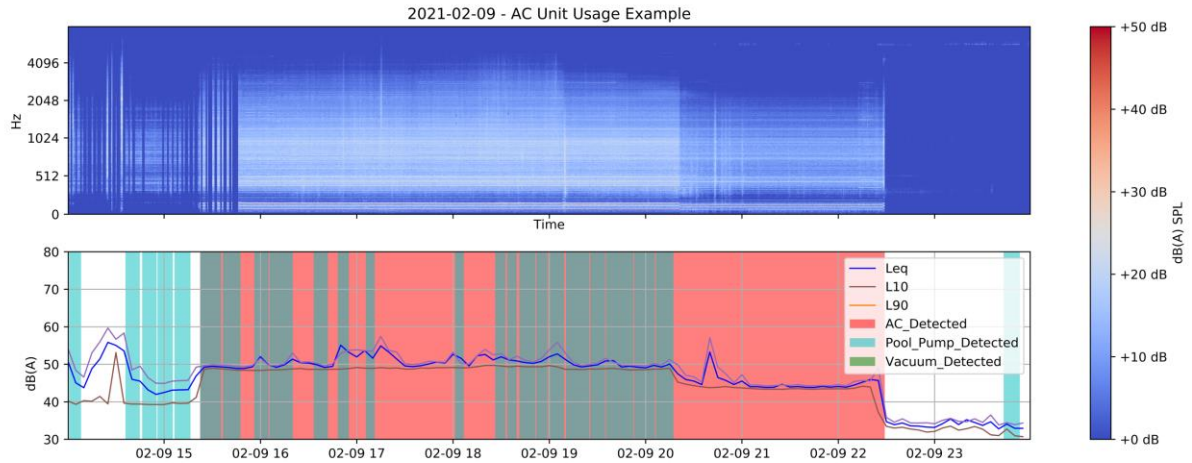
Figure 9, Figure 10 and Figure 11 show selected examples of the AC unit, beginning, during and ceasing operation. The impact from the AC unit on the acoustic environment is clearly observable, with the ambient noise level rising or falling approximately 10-15dB when the unit begins or ceases operation. While in operation, the AC unit is typically the primary source of noise at the monitoring location, with noise levels showing very little deviation while active.

Figure 9 – Operation of AC Unit (and other detected plant), 2021-02-09T14:00 to 2021-02-19T00:00

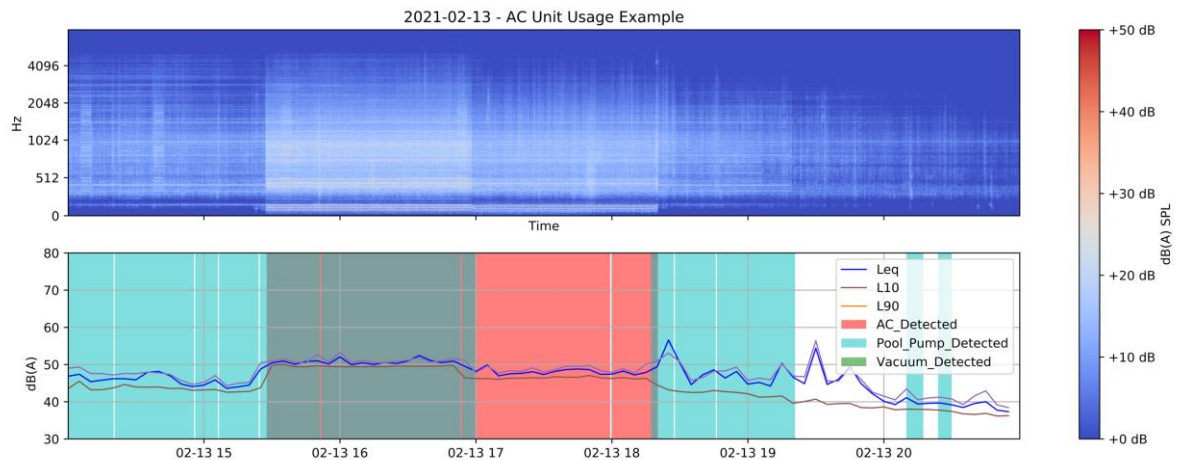
Figure 10 – Operation of AC Unit (and other detected plant), 2021-02-13T14:00 to 2021-02-13T21:00

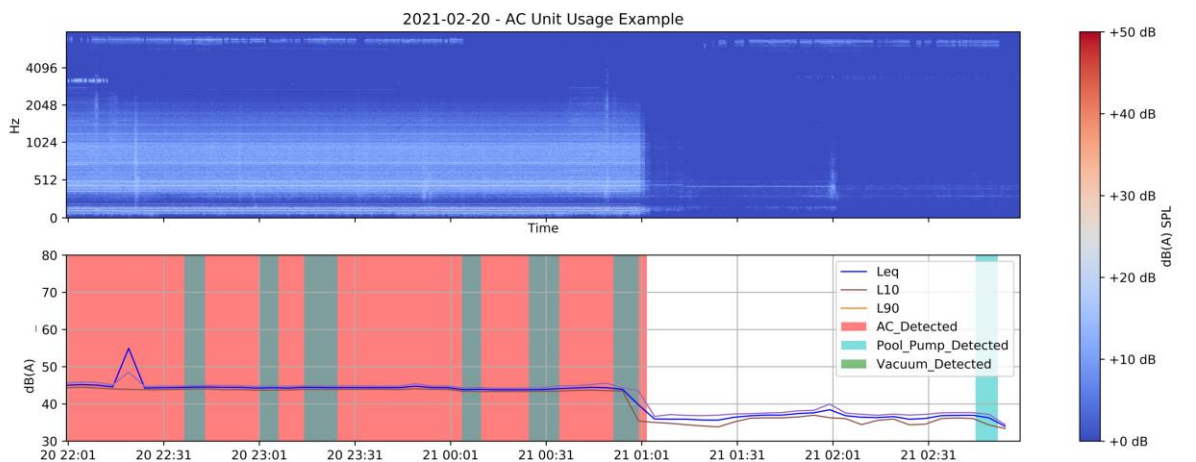
Figure 11 – Operation of AC Unit (and other detected plant), 2021-02-20T22:00 to 2021-02-21T01:00

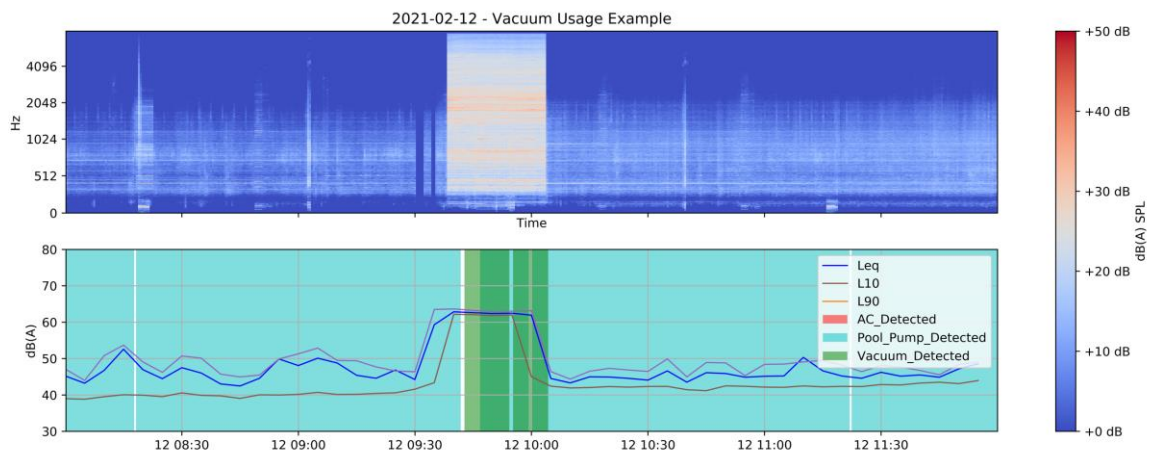
Figure 17 shows a selected example of the Vacuum in operation. The impact from the Vacuum system on the acoustic environment is clearly observable, with a consistent noise level approximately 20dB above background noise level at the time (which itself is primarily Pool Pump noise).

Figure 17 – Operation of Vacuum (and other detected plant), 2021-02-12T09:00 to 2021-02-12T12:00
